# Water mist catcher EUBv6

The efficient water mist catcher  
for your 2-stroke large diesel engine

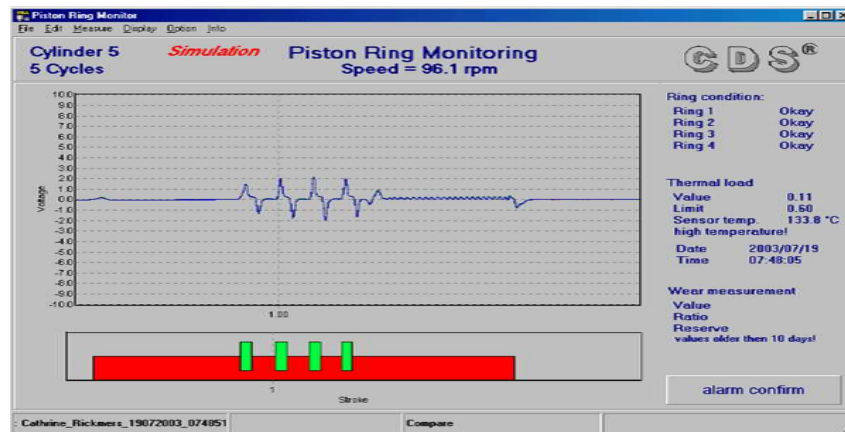
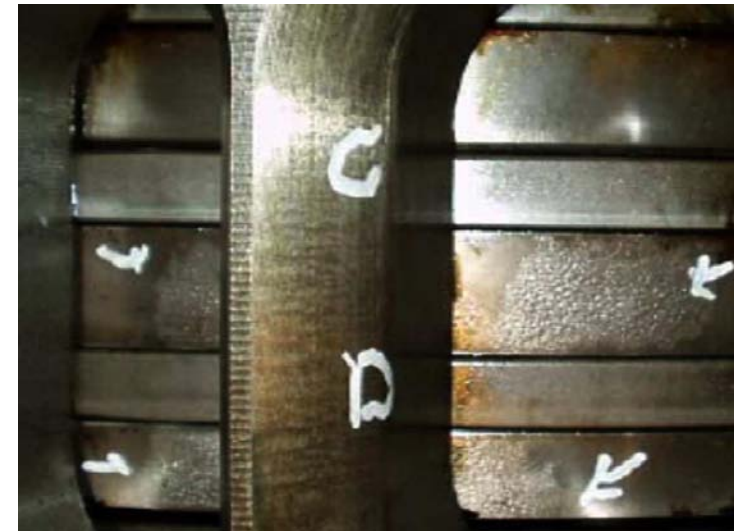
- Monitoring of liner temperature and piston rings by CDS-system
- Observation of unusual temperature developments on single stations
- Inspection of said stations through corresponding scavenging air ports
- Conspicuous damage symptoms

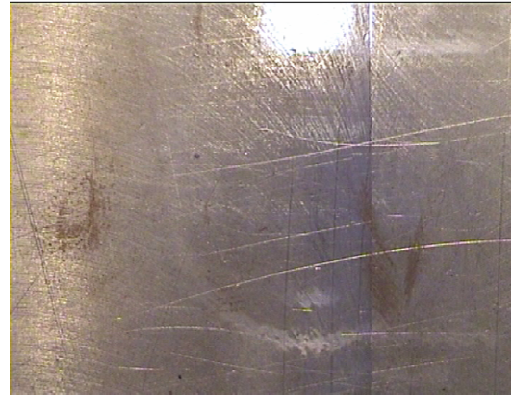
Liner wall with intact lubrication film

- Imported condensate in combustion chamber precipitates on liner wall
- Rapid transition from liquid to gaseous phase (micro explosion), during this increase of volume with factor 800
- Lubrication film is eliminated
- Local solid object friction and overheating occurs– **liner and piston damages**

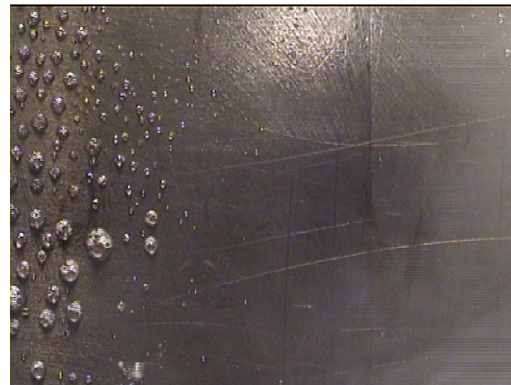
Liner wall without lubrication film after water spray

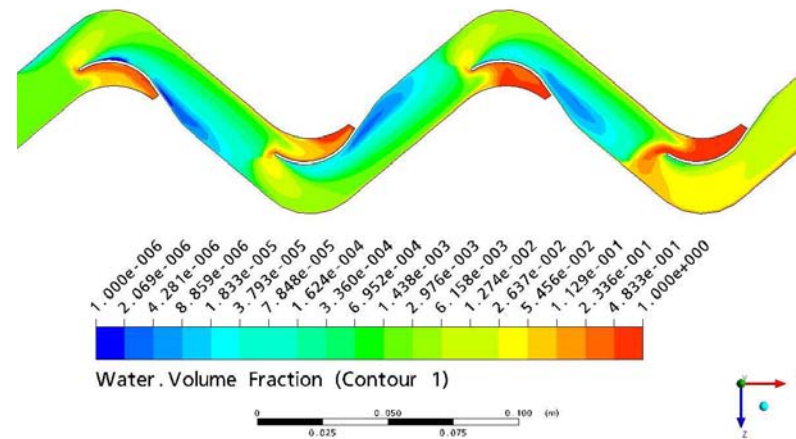
Result of simulation

➔ **With engines of series RTA 84 and 96 traditional WMC fail in service due to huge air intake volumes**

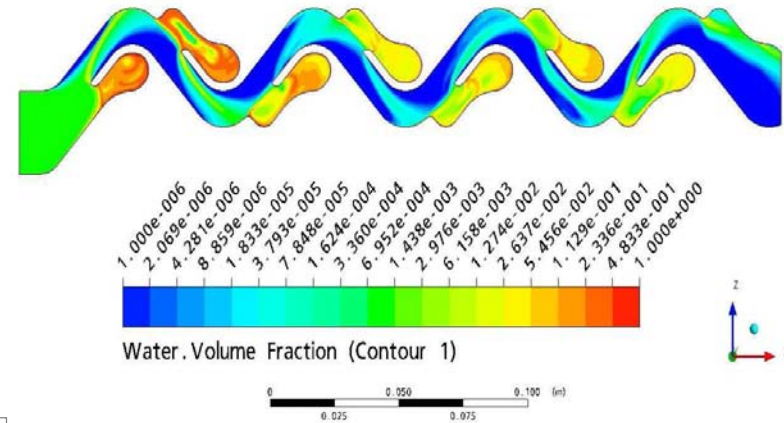
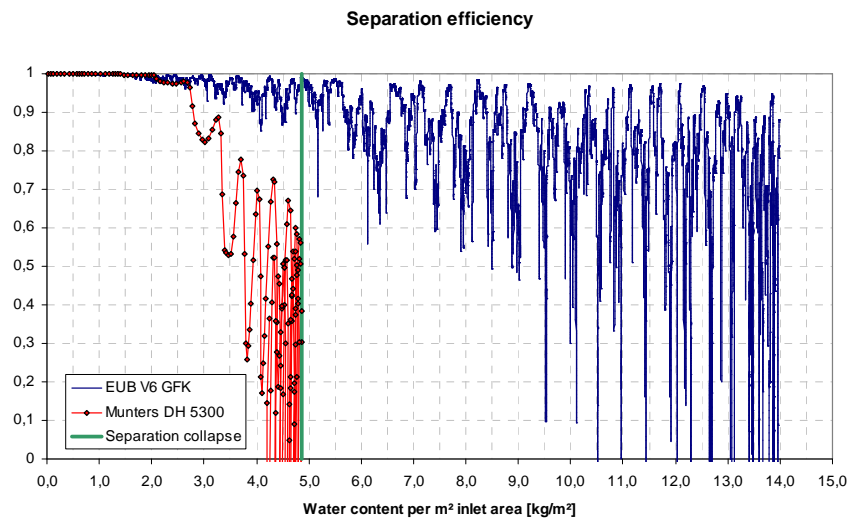
- Development of efficient catching profiles using numeric simulation
- Improvement of the whole construction
- Securing of easy to upgrade design
- Minimizing of pressure loss in charge air

→ Separation efficiency of EUBv6 significantly higher than OEM WMC

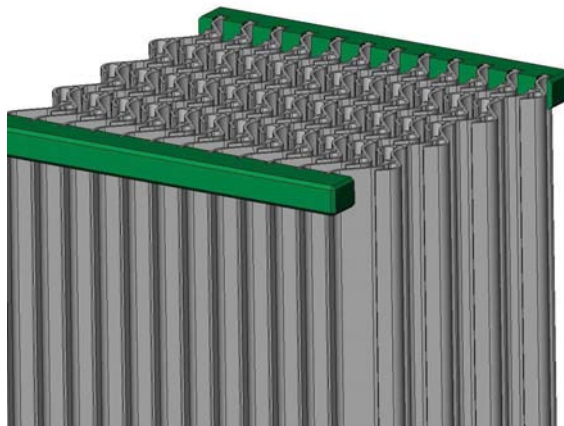
Blade package

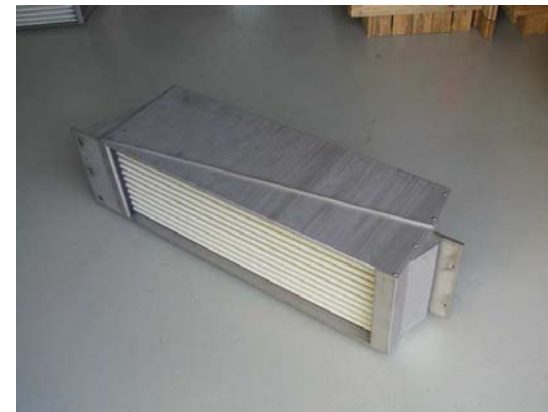
Catcher module for RTA84
